Fraunhofer
IPM

3D CT

Material and component analysis

For electronic components and printed circuit boards

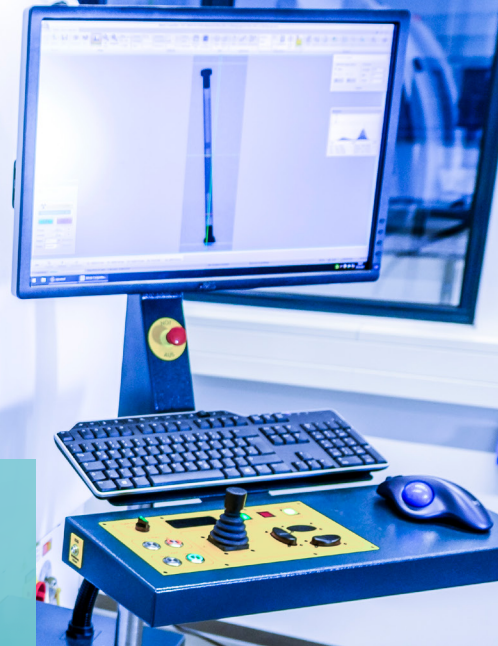
A look inside: 3D computed tomography makes it possible to identify defects inside components. Such hidden defects are often the cause of complete system failures, for example in electronics.

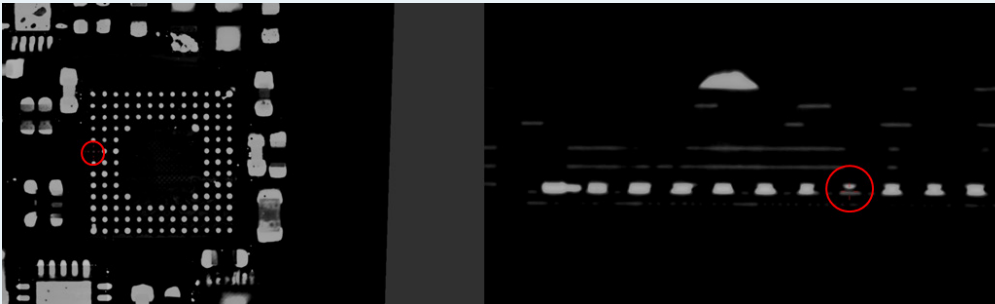
A faulty solder joint within a ball grid array (BGA) was identified as the cause behind the failure of a processor (marked in red).
